### COMMITTEE OF INQUIRY CONCLUDES STRING OF CRITICAL DESIGN ERRORS CAUSED COLLAPSE AT NICOLL HIGHWAY.

## THE FINAL REPORT FROM THE COMMITTEE OF INQUIRY INTO THE NICOLL HIGHWAY COLLAPSE – EXECUTIVE SUMMARY

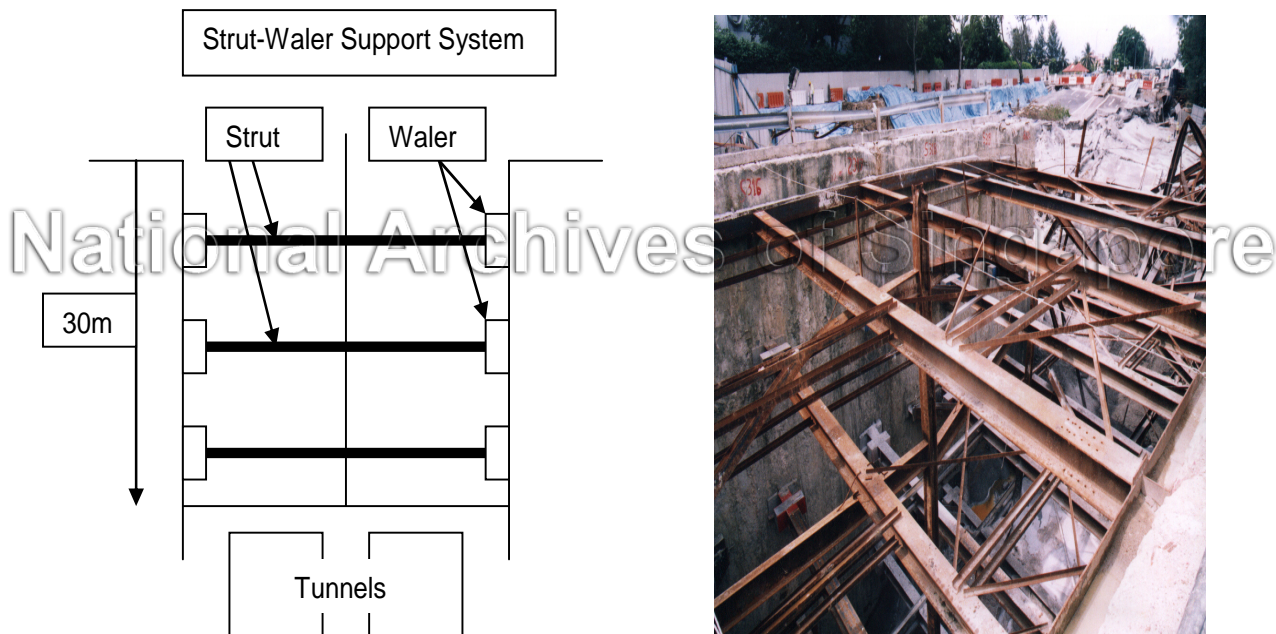
The registered occupier of the Nicoll Highway worksite is Nishimatsu Construction Company Limited (NCC). The “cut and cover” method was chosen to construct the underground tunnels between the Nicoll Highway and Boulevard stations. With this method, a large cavity, with retaining concrete walls, is progressively excavated from ground level to tunnel depth, which in this case was 33 metres. As the cavity gets deeper, the retaining walls are braced with a strut-waler support system. This system comprises steel bars (struts) which are connected to bars running parallel to the walls (walers). The purpose of the walers is to distribute the forces exerted by the struts along a larger surface area of wall. When work is completed within the cavity, it is filled back with soil.

At about 3.30pm on 20 April 2004, a collapse occurred at part of the excavation site known as “Type M3”, which was directly adjacent to the Nicoll Highway. At the time of collapse the cavity had reached about 30 metres in depth.
