COMMITTEE OF INQUIRY CONCLUDES STRING OF CRITICAL DESIGN ERRORS CAUSED COLLAPSE AT NICOLL HIGHWAY.

THE FINAL REPORT FROM THE COMMITTEE OF INQUIRY INTO THE NICOLL HIGHWAY COLLAPSE – EXECUTIVE SUMMARY

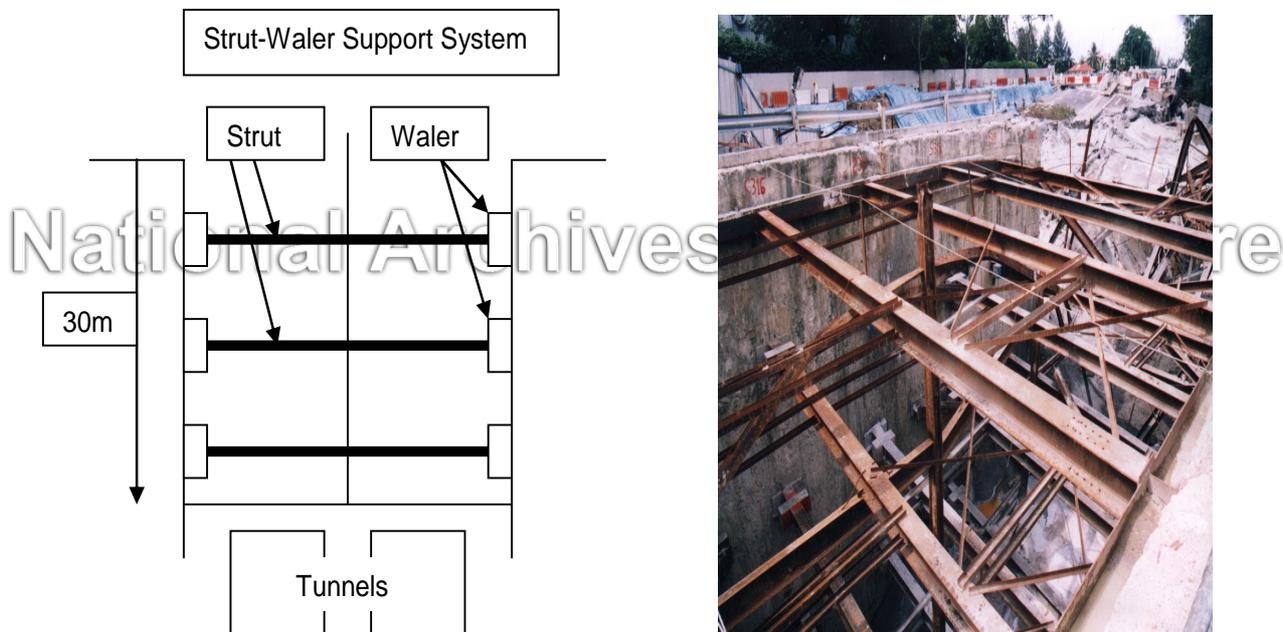
The registered occupier of the Nicoll Highway worksite is Nishimatsu Construction Company Limited (NCC). The “cut and cover” method was chosen to construct the underground tunnels between the Nicoll Highway and Boulevard stations. With this method, a large cavity, with retaining concrete walls, is progressively excavated from ground level to tunnel depth, which in this case was 33 metres. As the cavity gets deeper, the retaining walls are braced with a strut-waler support system. This system comprises steel bars (struts) which are connected to bars running parallel to the walls (walers). The purpose of the walers is to distribute the forces exerted by the struts along a larger surface area of wall. When work is completed within the cavity, it is filled back with soil.

At about 3.30pm on 20 April 2004, a collapse occurred at part of the excavation site known as “Type M3”, which was directly adjacent to the Nicoll Highway. At the time of collapse the cavity had reached about 30 metres in depth.
