COMMITTEE OF INQUIRY CONCLUDES STRING OF CRITICAL DESIGN ERRORS CAUSED COLLAPSE AT NICOLL HIGHWAY.

THE FINAL REPORT FROM THE COMMITTEE OF INQUIRY INTO THE NICOLL HIGHWAY COLLAPSE – EXECUTIVE SUMMARY

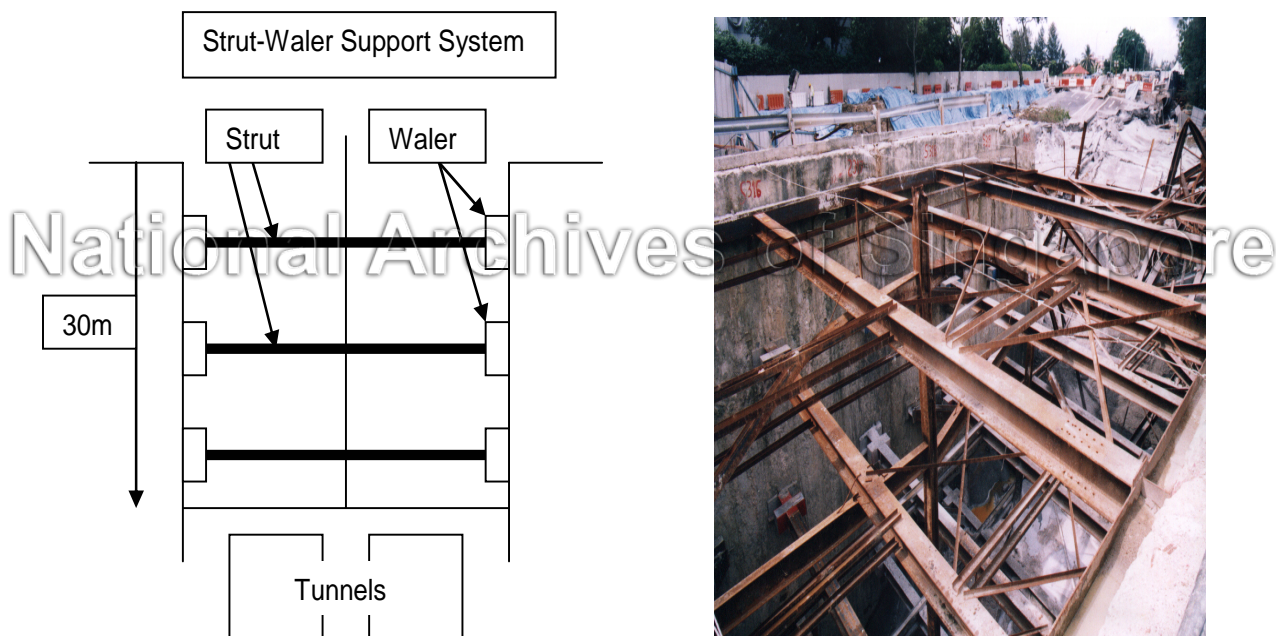
2 The Committee concluded that the Nicoll Highway collapse was initiated by the failure of the strut-waler support system for the excavation at the nearby MRT Circle Line project C824. On the day of the collapse, several walers buckled, leading to an eventual cave-in of the retaining walls of the excavation site. (Please refer to Annex B for a diagram of the accident site.)

The registered occupier of the Nicoll Highway worksite is Nishimatsu Construction Company Limited (NCC). The “cut and cover” method was chosen to construct the underground tunnels between the Nicoll Highway and Boulevard stations. With this method, a large cavity, with retaining concrete walls, is progressively excavated from ground level to tunnel depth, which in this case was 33 metres. As the cavity gets deeper, the retaining walls are braced with a strut-waler support system. This system comprises steel bars (struts) which are connected to bars running parallel to the walls (walers). The purpose of the walers is to distribute the forces exerted by the struts along a larger surface area of wall. When work is completed within the cavity, it is filled back with soil.

At about 3.30pm on 20 April 2004, a collapse occurred at part of the excavation site known as “Type M3”, which was directly adjacent to the Nicoll Highway. At the time of collapse the cavity had reached about 30 metres in depth.
