# 7 OCTOBER 2017 TUNNEL FLOODING INCIDENT BETWEEN BISHAN AND BRADDELL MRT STATIONS

Ministerial Statement by Coordinating Minister  
For Infrastructure and Minister for Transport

7 Nov 2017

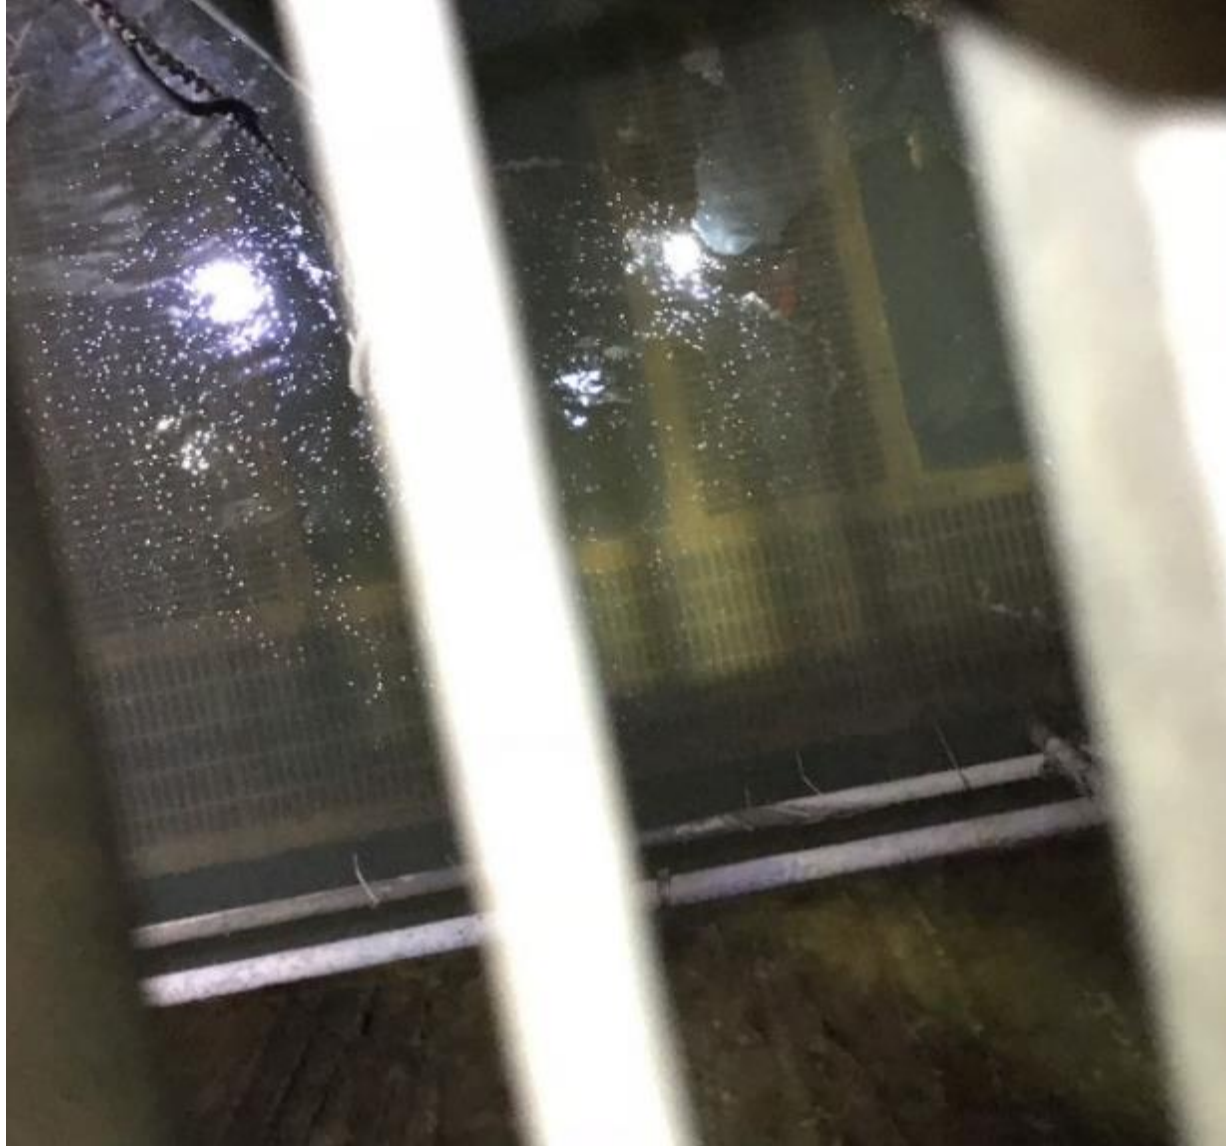
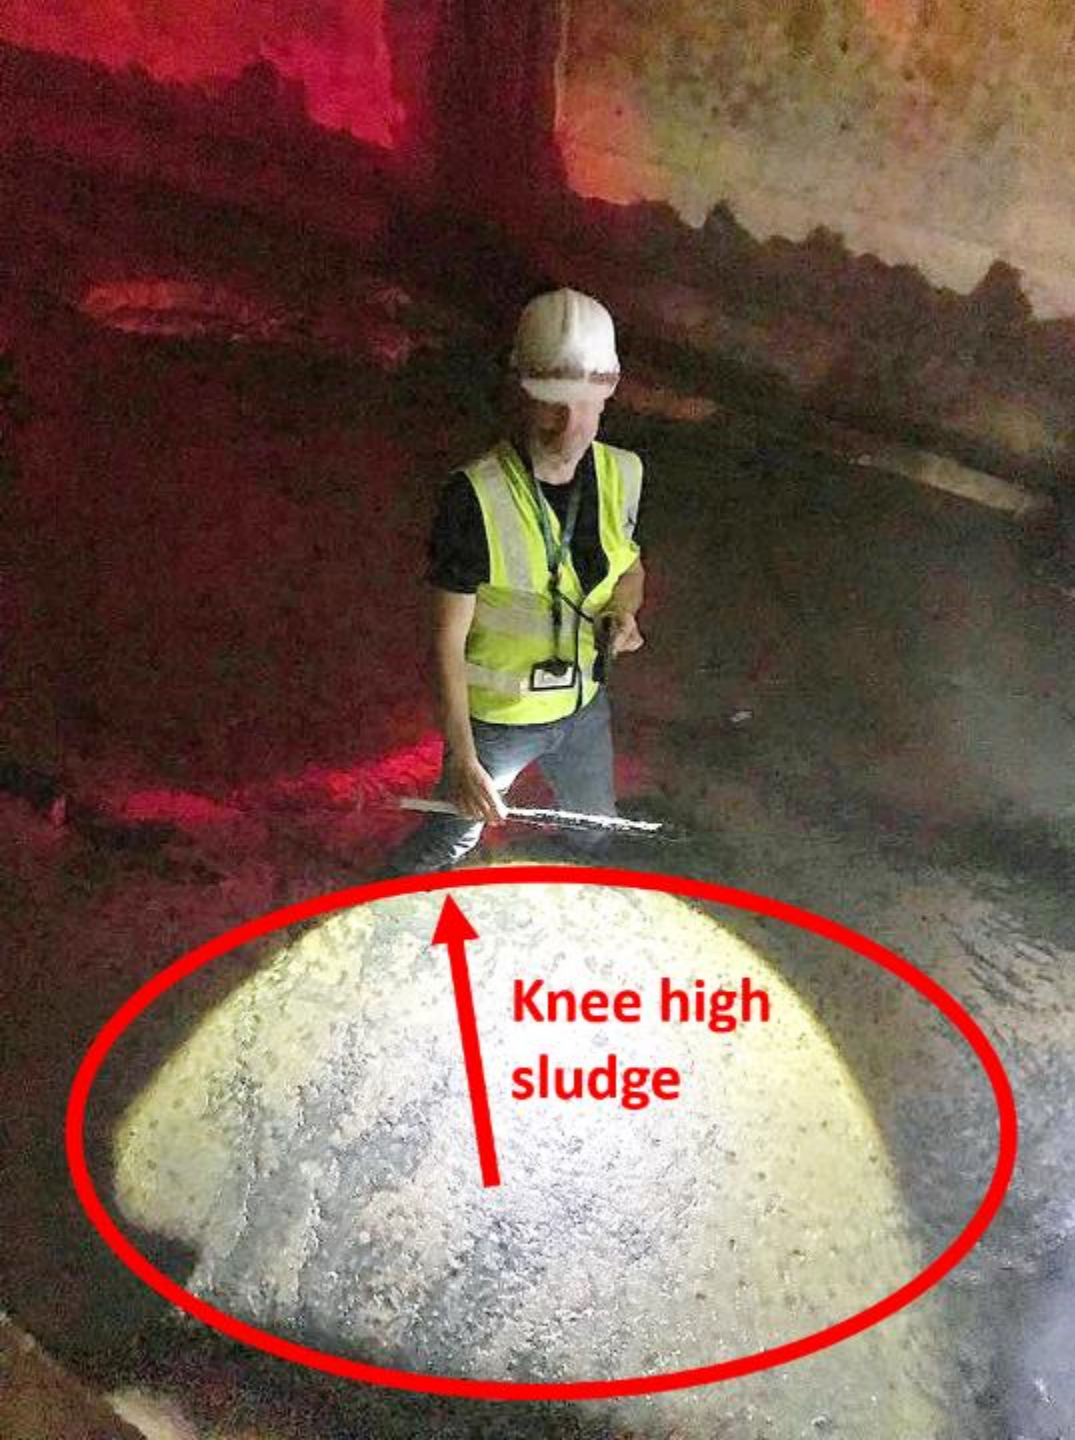
The water level inside the sump pit is easily visible through the grating on top. Maintenance checks would have quickly established if the pit was full.

A properly maintained storm water sump pit should be clean, free of sludge, silt and debris, and empty in anticipation of the next storm so that it can do its job.
