7 OCTOBER 2017 TUNNEL FLOODING INCIDENT BETWEEN BISHAN AND BRADDELL MRT STATIONS

Ministerial Statement by Coordinating Minister
For Infrastructure and Minister for Transport

7 Nov 2017

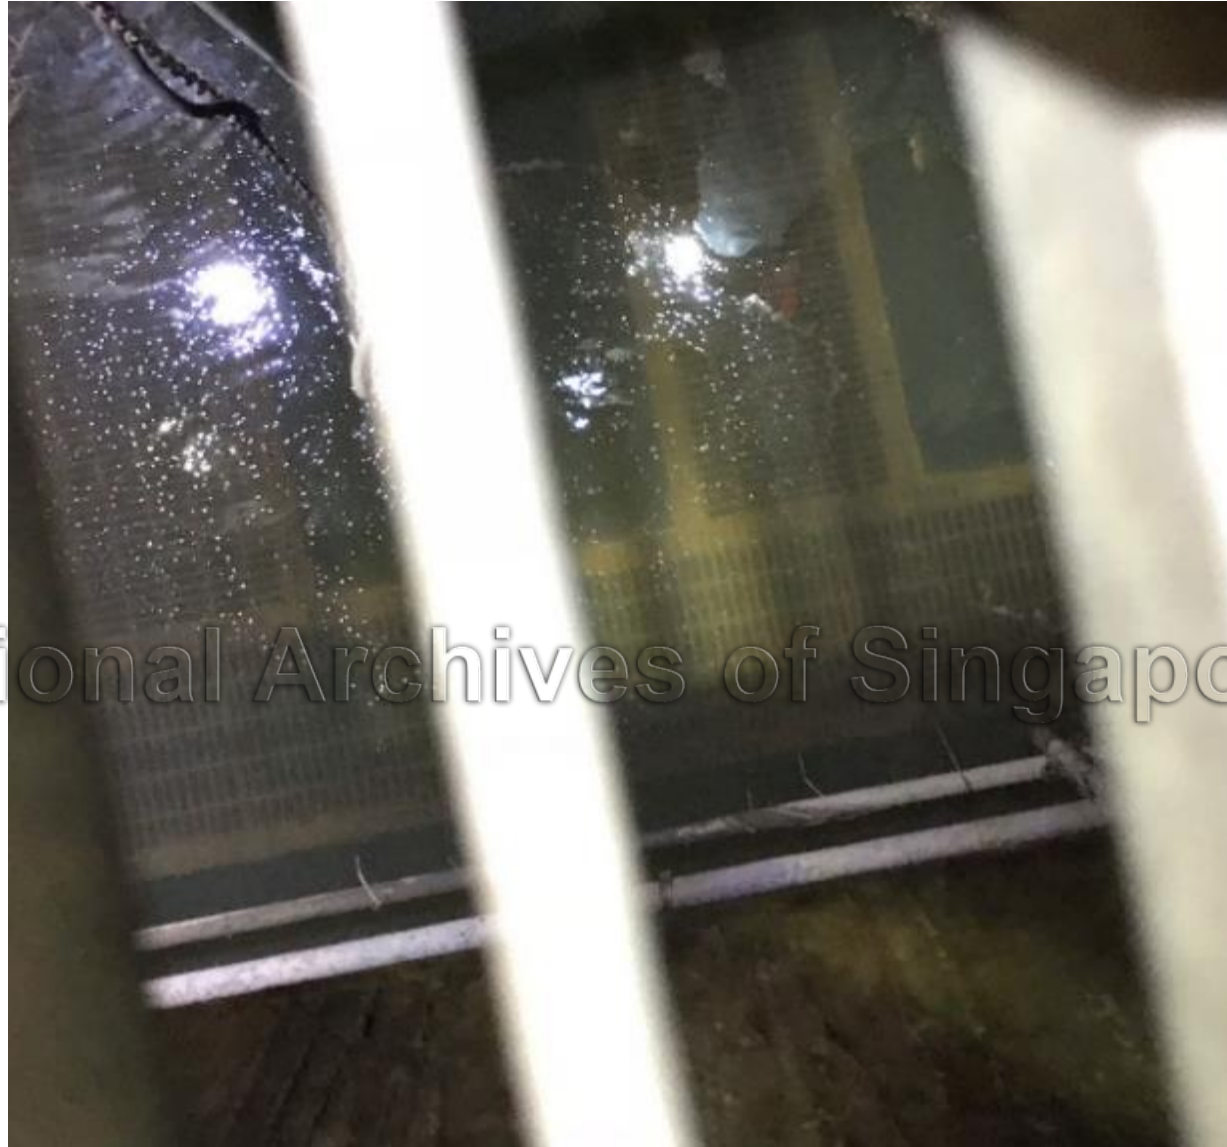
The water level inside the sump pit is easily visible through the grating on top. Maintenance checks would have quickly established if the pit was full.

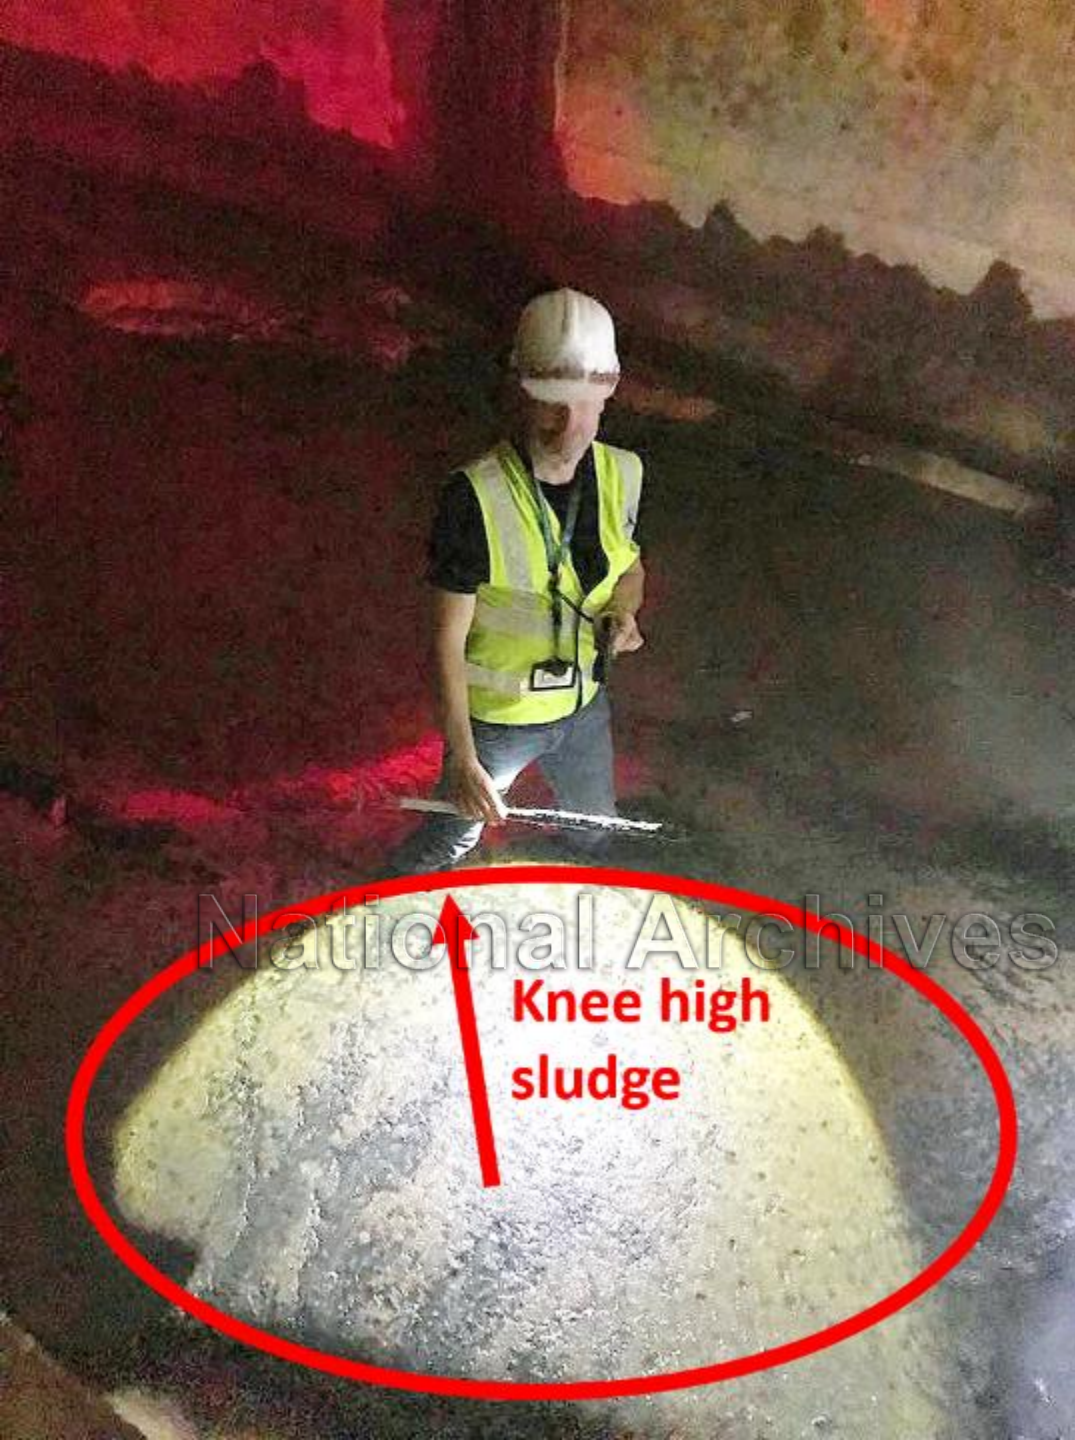
A properly maintained storm water sump pit should be clean, free of sludge, silt and debris, and empty in anticipation of the next storm so that it can do its job.
